# Manhole Inspection Summary

Manhole # S21GG\_035MH

Insp Date: **6/15/07 10:15 AM**

**Location** Address: **1602 FULTON AVE**

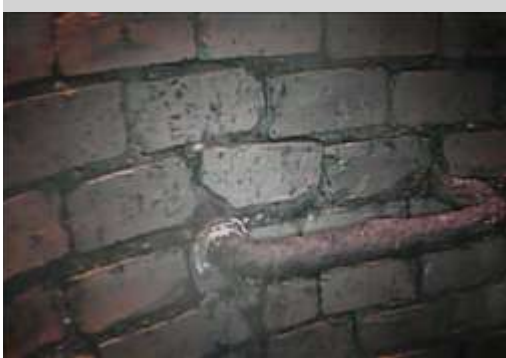
Defect 3

☒ Evidence Of Surcharge Depth: **4** (ft.) ☐ Active Surcharge Present

SURCHARGE EVIDENCE ON STEPS

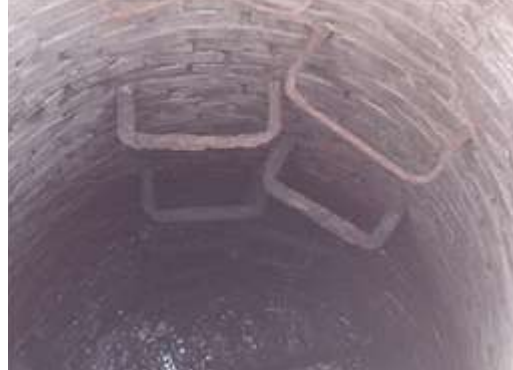
Defect 2

Count: **9** Missing: **2** ☒ Corroded

CORRODED AND MISSING STEPS

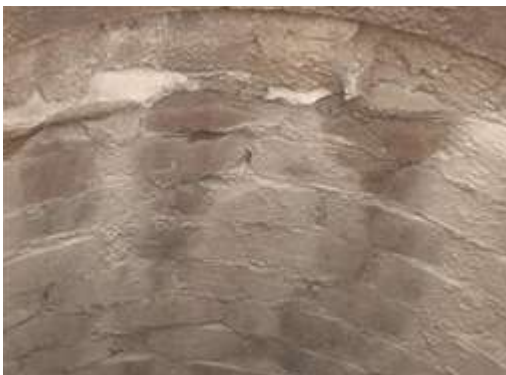
Defect 1

Infiltration: ☐ None ☐ Joint ☐ Cracks ☐ Mortar ☐ Roots ☒ Wall

INFILTRATION OF CORBEL
